## An Assessment of Bank Erosion Along Indian Run

Throughout the summer of 2004, Lycoming College Clean Water Institute interns hiked the full 2 miles of Indian Run in Danville, Pennsylvania. The interns assessed the Run from its emergence along Indian Run Road to its confluence with Mahoning Creek. All occurrences of erosion were documented using a form identical to the one found in the appendix. In all, 59 disturbances were observed along Indian Run and are presented in Table 1 and Figure 1. Of these, 9 were bridges (15.52% of total disturbances) and 6 were pipes flowing into the Run bed (10.34% of total disturbances). There were 6 instances of rip rap (10.34% of total disturbances) along the banks and 1 concrete wall impeding water flow (1.72% of total disturbances). There were 10 deposition bars (17.24% of total disturbances) throughout the Run bed. There was 1 area (1.72% of total disturbances) where the Run was used as a horse crossing. There were 2 tributaries (3.45% of total disturbances) observed. There were 24 instances of erosion documented along the Run (41.38% of total disturbances), 13 of which were on the right banks (54.17% of total erosion sites), while 11 were on

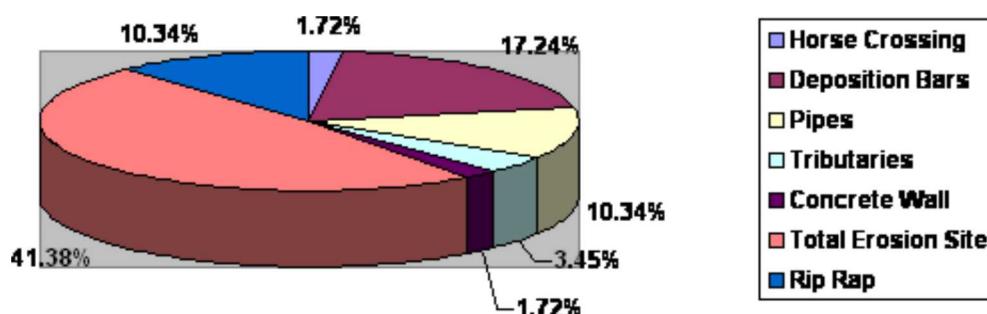
Figure 1. Summary of disturbances along Indian Run.
